ARMY CONCEPT TEAM IN VIETNAM  
APO San Francisco 96243

SEARCHLIGHT  
ILLUMINATION (U)

30 November 1965

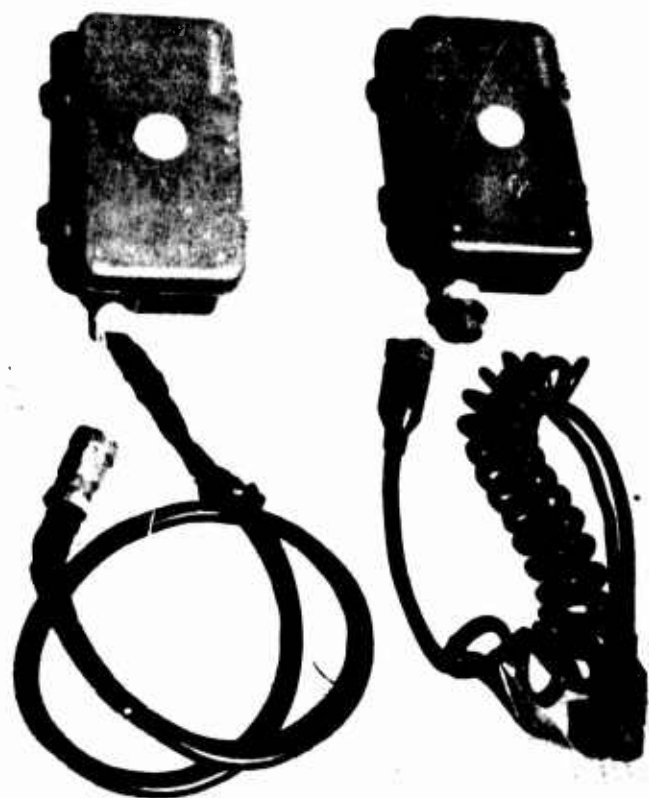
<u>Deficiency</u>	<u>Corrective Action</u>	<u>Remarks</u>
Control box cables were of poor strength and durability.	Cables were replaced with new hardened, bonded cables sent from ERDL (figure E-1)	No difficulty was encountered with the new cables.

(U) FIGURE E-1. Control box cables (new bonded cable on right).
